## LSPS Diagnostic Campaign

## Loop Schematic & SC PLEM 2 Valve

## Campaign 1 - Insulation Removal Summary (9/3)

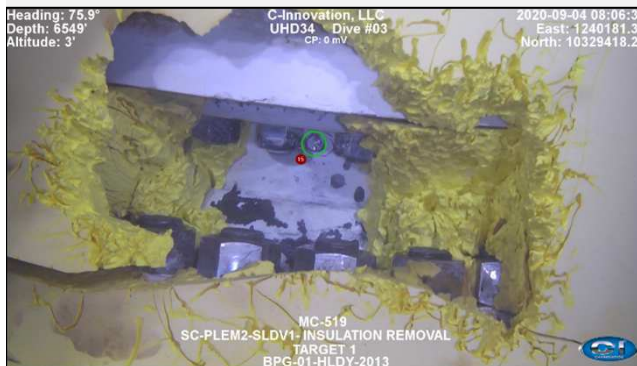
Target 1 Starboard

- Insulation removal authorized on SLDV1 at SC2 PLEM (5k Water Blaster instead of CT)
  - Target 1: Grease port not located on starboard side. Identified as NPT Plug
  - Target 2: Grease port located. Lockwire appears functional & installed correctly
  - Target 3: Large section removed, indicating lack of adhesion/bonding to the valve

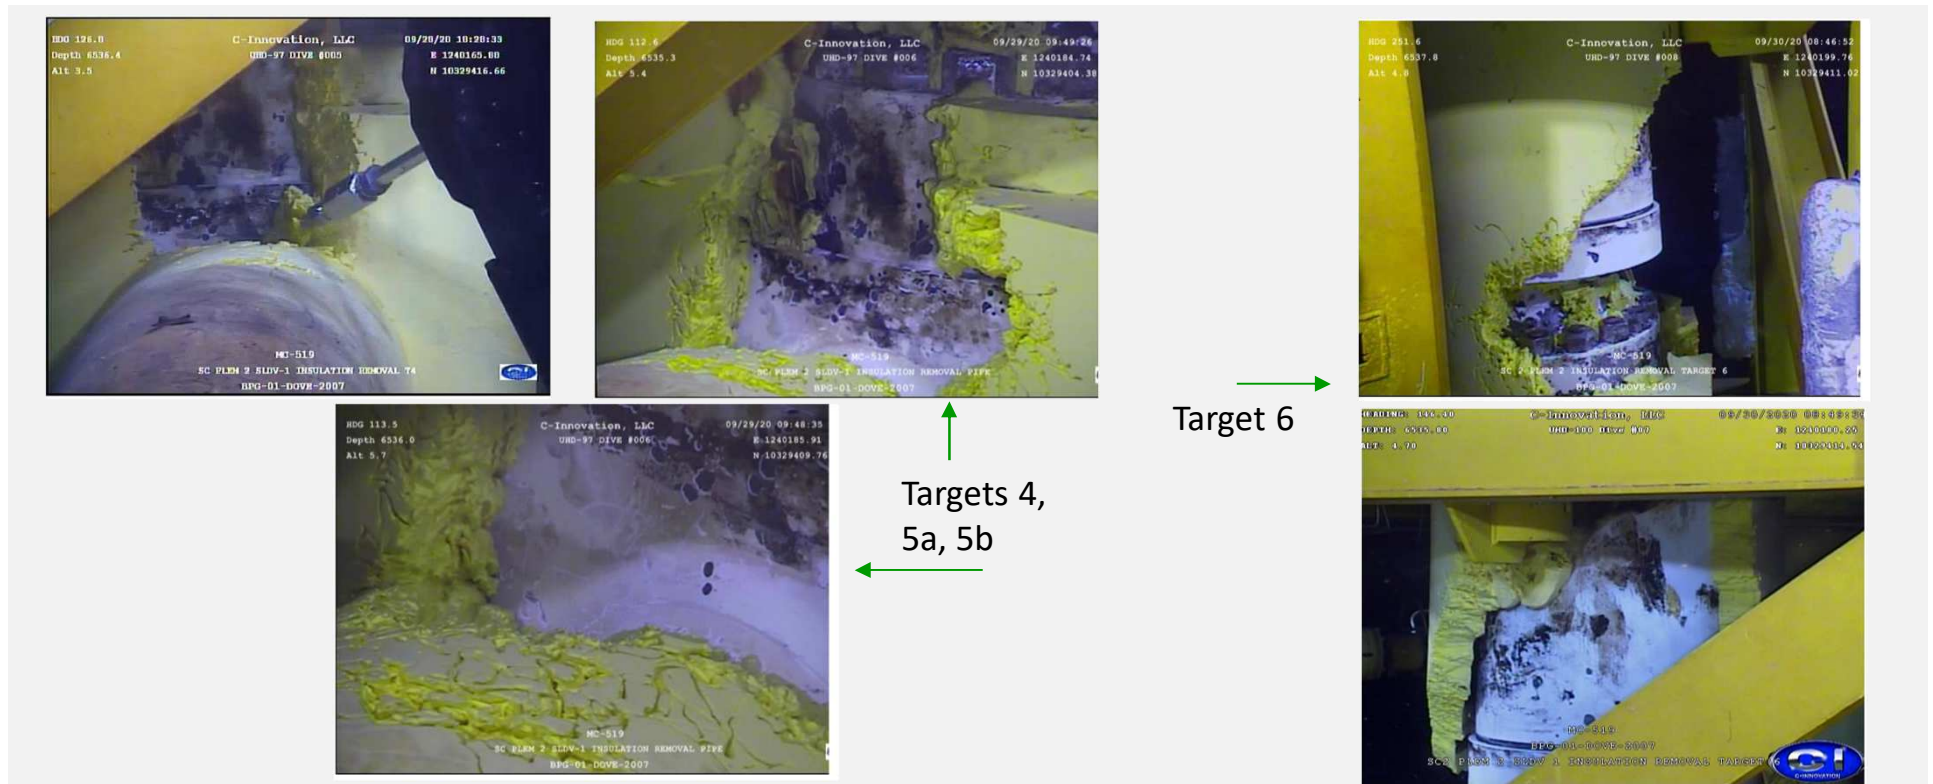
## Campaign 2 - Insulation Removal Summary (9/25)

- Received BSEE Approval of CAP on 9/14. Mobilization planned for 9/18
  - Install containment dome
  - Increase pressure in the PLEM
  - Confirm egress at grease ports
  - Tighten grease ports and reinstate
- Campaign started on 9/25 (weather delays)
- Pressurization through BH3 cap failed due to lack of bore communication
- *Additional Insulation Targets added to scope*
  - *Target 4 ,5a/5b (Follow the path of staining)*
  - *Target 6 (Revisit Target 3)*
